Energy Efficiency Related Lessons Learned

Kevin Regimbal

November 16, 2015

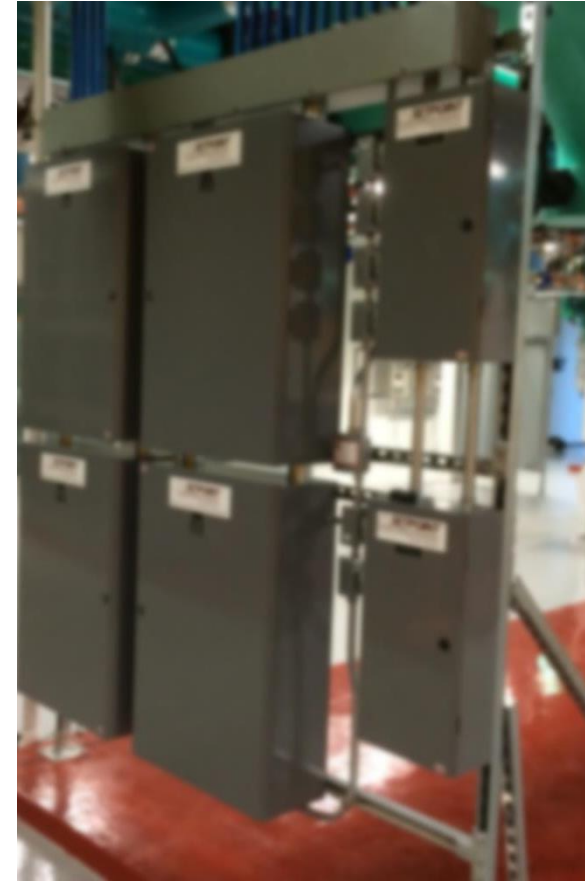
- Planned troubleshooting activity required power down / lock out of electrical panel that powers the Building Automation System (BAS) panels that manage data center cooling systems.
- Similar activities had been performed without impact to the data center cooling systems, so it was believed this work would not affect cooling.

- Test systems so you know how they will work when:
 - Normal power is interrupted
 - Emergency power interrupted
 - A BAS panel fails
 - Smoke Detectors are tested
- Validate that computer systems will protect themselves in a loss of cooling event.

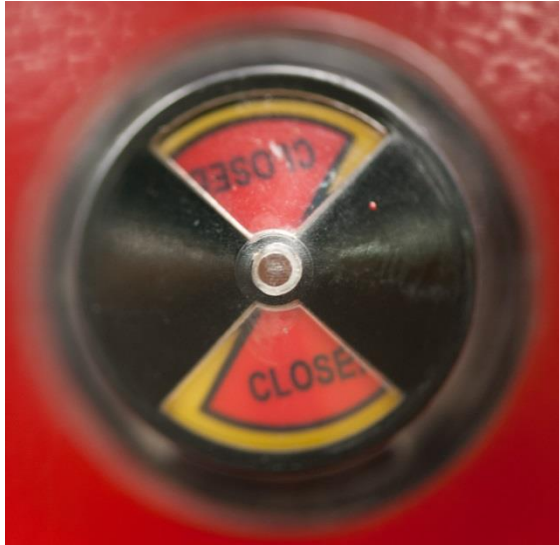
Event 1: May 12 – Data Center Sequence of Events

- ~7:40 AM BAS control panels that controlled the energy recovery loop pumps for the Data Center cooling system were de-energized.
- Valves for the energy recovery loop closed.
- Loss of flow was detected at 7:43.
- The BAS was restored at ~ 8:10 AM.

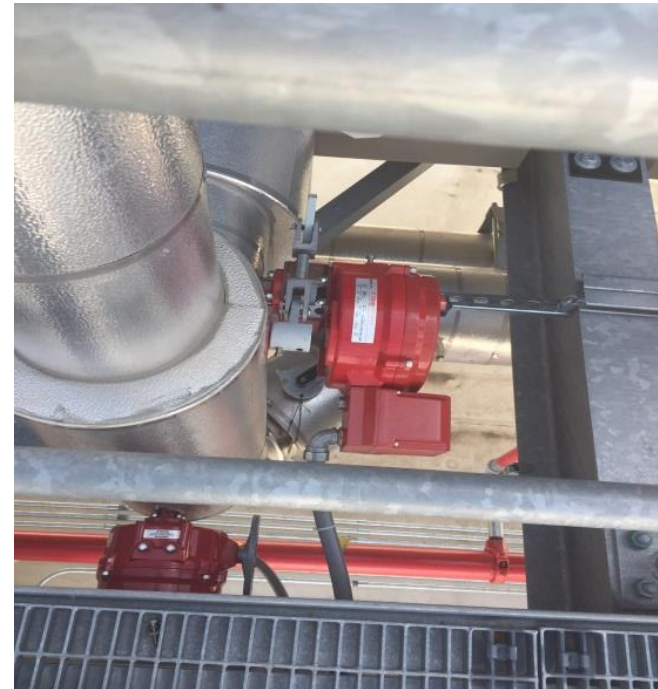
- Water flowing out of the Data Center cooling towers and into the heat exchanger was not as cool as it should have been.
- As a result, water coming from the Data Center energy recovery water loop could not transfer as much heat to the water in the cooling tower loop.
- Between 04:11 and 05:11, temperatures in energy recovery loop were high but increasing gradually.

- Tower B – End switch on isolation valve failed to send a signal back to ramp up pump flow
- Tower C – Actuator on 3 way valve failed, locking valve open, which directed water directly into basin (minimal cooling effect).

- Preventative Maintenance Best Practice:
 - Specific checklist instead of general guidance so that tests are consistent and documented.
 - Test proper response to each control signal, and validate that sensor readings match.
- Improve Programming:
 - Alert when there is a mismatch between BAS signal and valve position sensors.

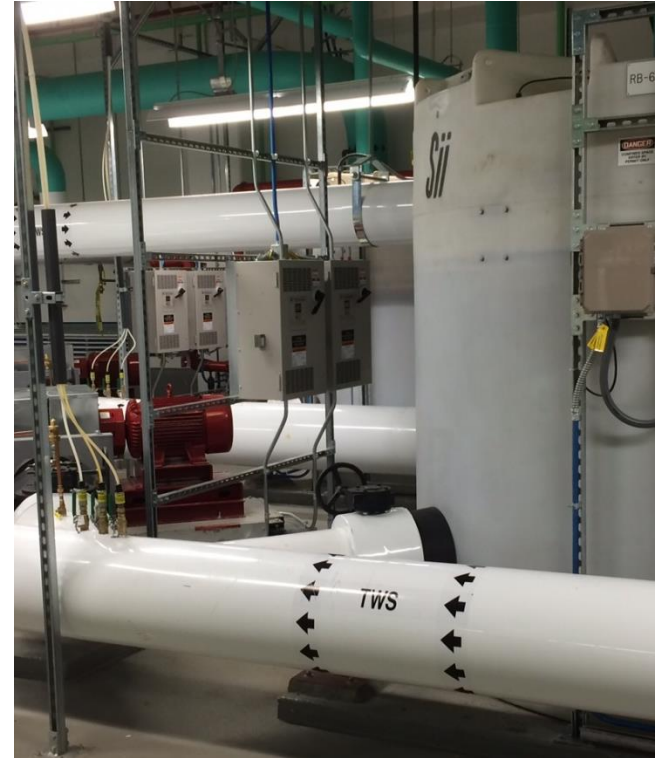
- ESIF cooling tower loop uses a remote sump tank design. When a tower is not in use, water drains down to a tank.
- Pumps draw their water from the bottom of the tank.
- Built in air separator right?

- BAS switched lead pump 09:00 (every Tuesday)
- 2 pumps ran through the day until about 17:30
- Temperature alarm at 18:06. ERWS water to CDUs passed 71F degrees.
- 18:13 returned to normal
- 19:00 temperature alarm again
- 19:06 returned to normal

- Why: lead pump became air bound. BAS started 2nd pump when temperatures got high enough to return to normal.

- Install automatic air purge devices. The ports are probably already there.
- Set up BAS alerts when pump speed and measured flow are inconsistent.
